UL 2596 Test Report for Elven Technologies Battery Enclosure: FireGuard Pro

Report Number: ET-UL-2596-2024-001

Project Name: Battery Enclosure Safety Program

Test Standard: UL 2596

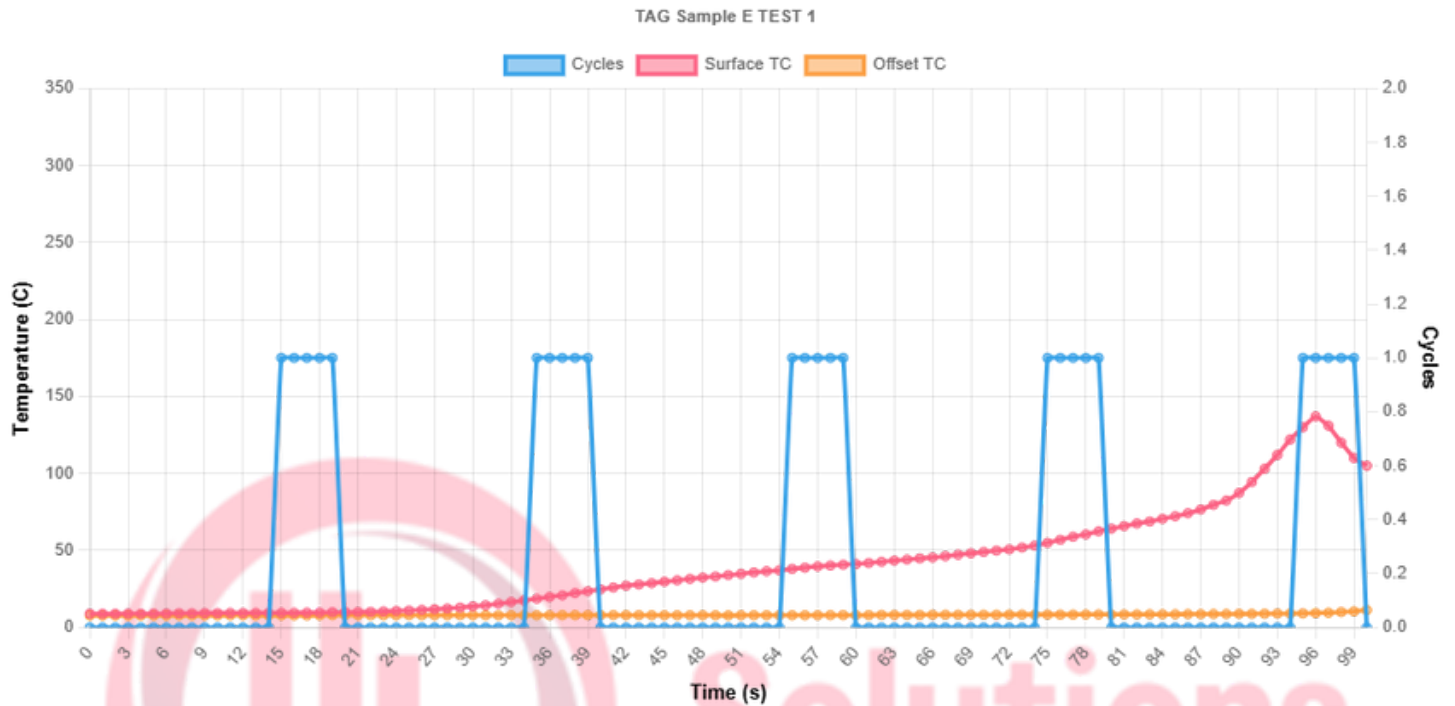
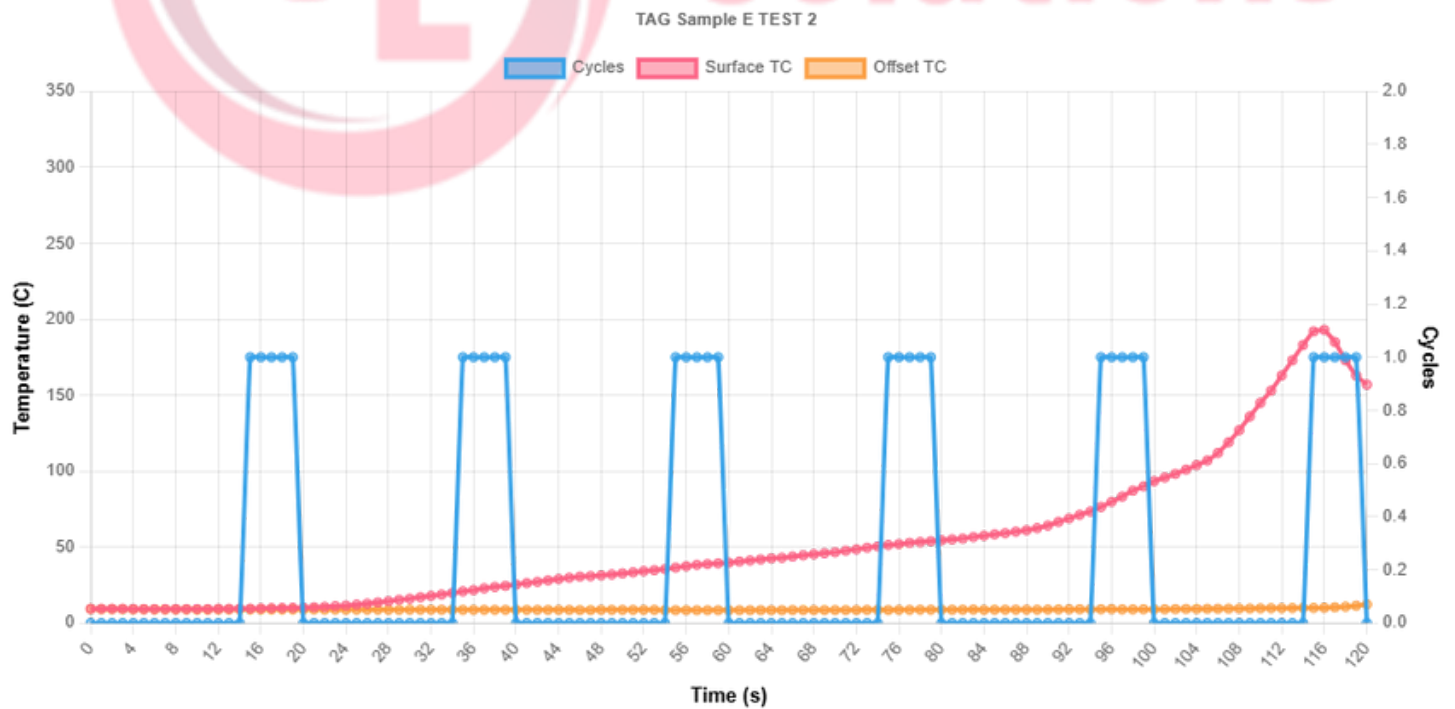
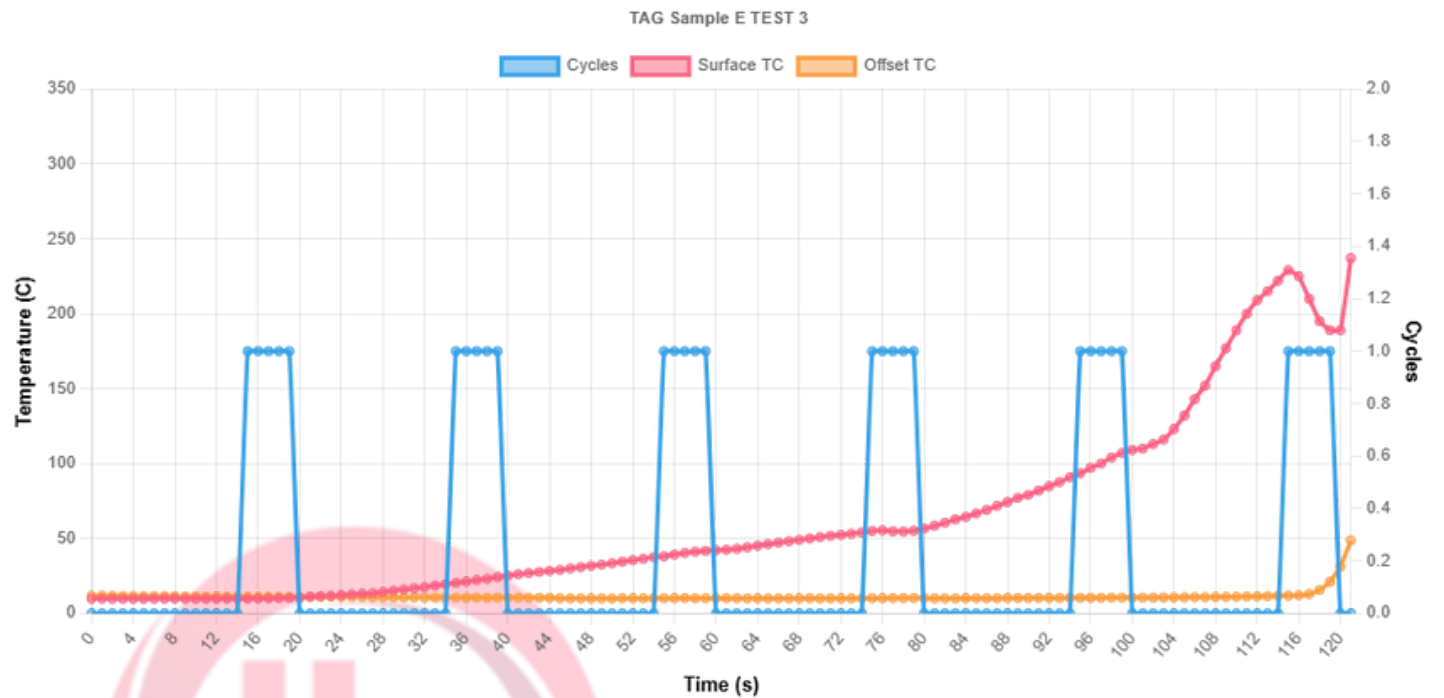
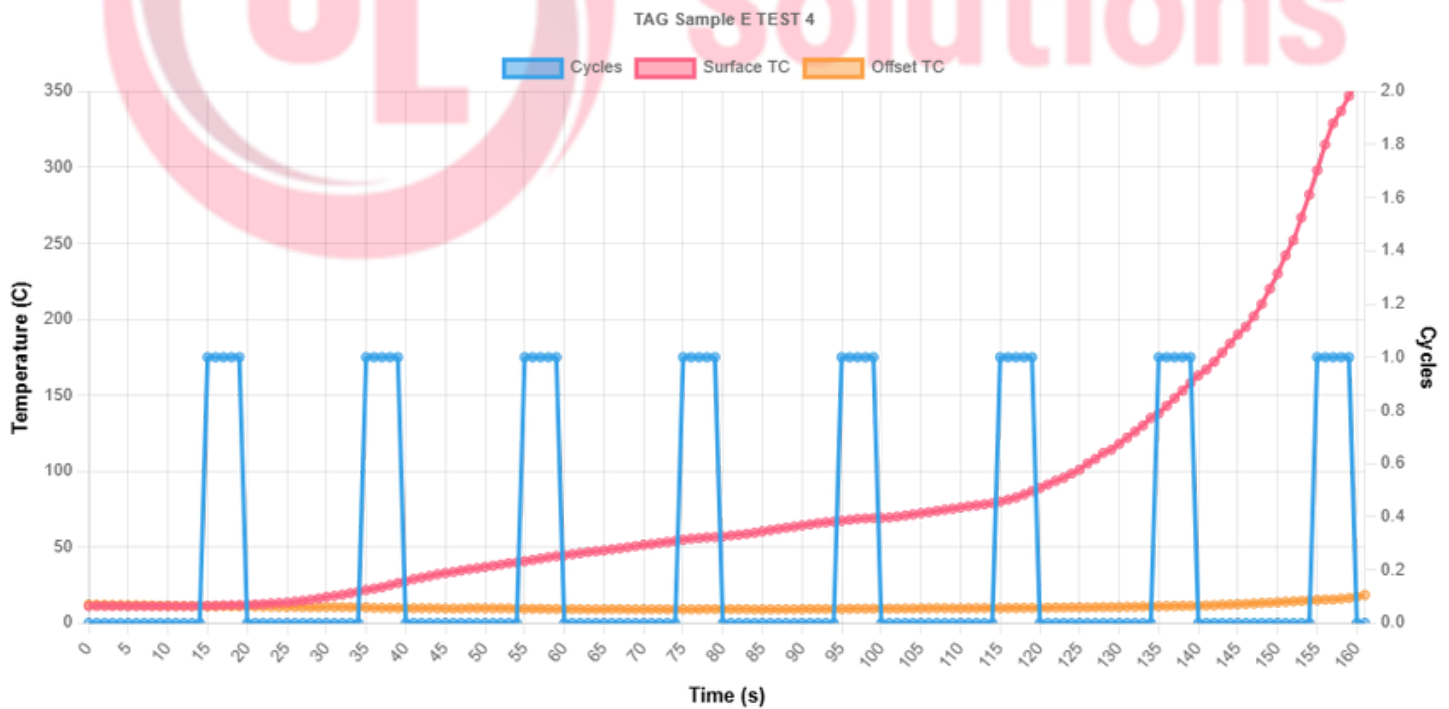
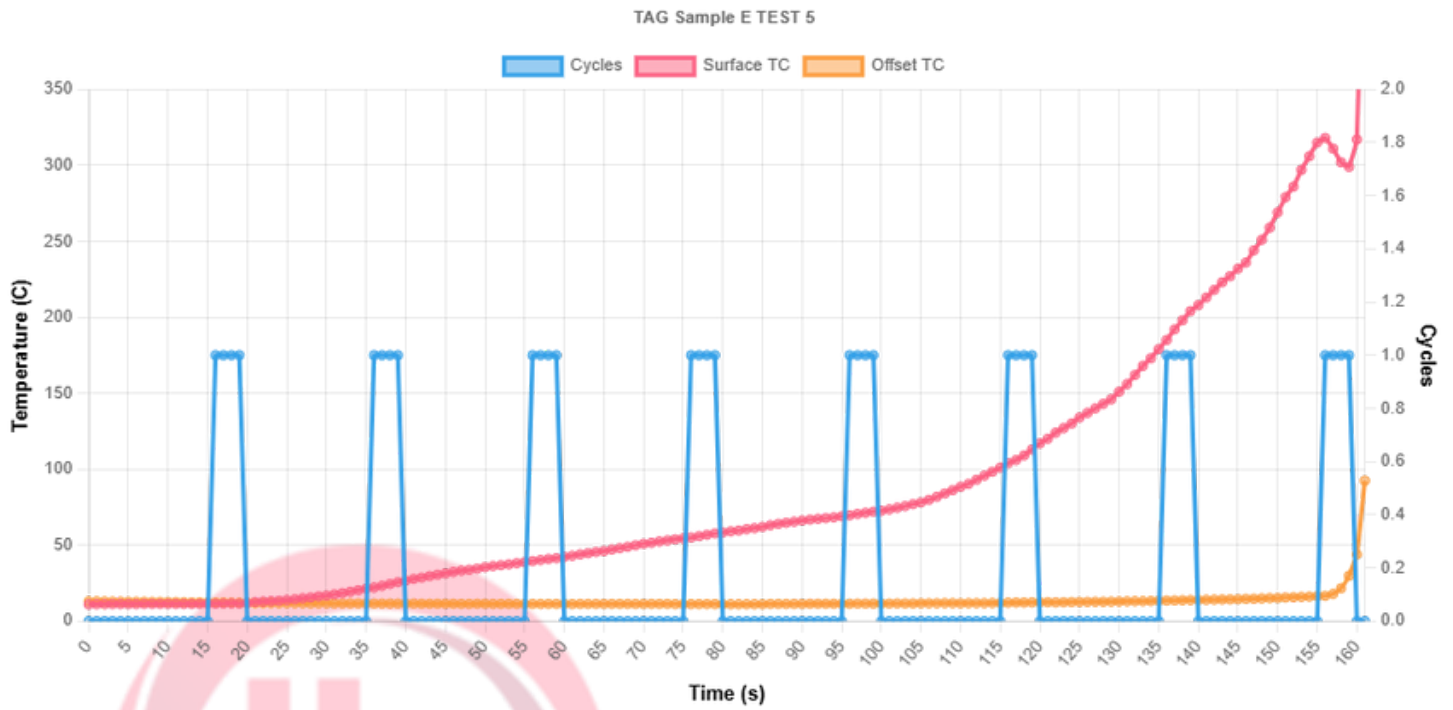
Temperature Profiles

Sample	Torch Temperature and Power Set Point	Torch Dwell Time	Grit Dwell Time	Sample Breach (Y/N)	Approximate Time to Sample Breach (s)	Temperature Measurement at Breach (°C)	Observations (Note: Temperature measurements charts are included in Addendum "A")
TAG Sample E TEST 1	1200 °C 3 KW	15s	5s	Yes	96	137	Breach at cycle 5 grit
TAG Sample E TEST 2	1200 °C 3 KW	15s	5s	Yes	115	192	Breach at cycle 6 grit
TAG Sample E TEST 3	1200 °C 3 KW	15s	5s	Yes	116	225	Breach at cycle 6 grit
TAG Sample E TEST 4	1200 °C 3 KW	15s	5s	Yes	158	337	Breach at cycle 8 grit, Front side material self ignition observed before breach
TAG Sample E TEST 5	1200 °C 3 KW	15s	5s	Yes	156	318	Breach at cycle 8 grit

- **Exposure & outcome:** Under a 1200 °C torch (15 s flame + 5 s grit per cycle), five replicates **breached during the grit phase** between **cycle 5 and cycle 8** (≈ 96–158 s total exposure).
- **Back-face temperatures at breach:** ~137–337 °C, indicating solid short-duration thermal shielding prior to through-penetration.
- **Thermal profile before breach:** Protected side stayed markedly cooler than the hot face; no sustained flaming observed on the protected side.
- **Failure mode:** **Localized pinhole** in the primary exposure zone; **no fragment ejection** and laminate remained largely bonded (no broad delamination).
- **Aggregate planning numbers:** Mean **time-to-breach** ≈ **128 s** (median ≈ 116 s); mean **T_{back-face}** ≈ **242 °C** at breach.
